Report No. ARAIB/AAR0801

AIRCRAFT ACCIDENT REPORT

**CRASHED INTO TERRAIN DURING LANDING
THE KOREA FAMILY FEDERATION MISSIONARY FOR
WORLD PEACE AND UNIFICATION
S92A2, HL9292
GAPYEONG-GUN, GYEONGGI-DO, REPUBLIC OF KOREA
19 JULY 2008**

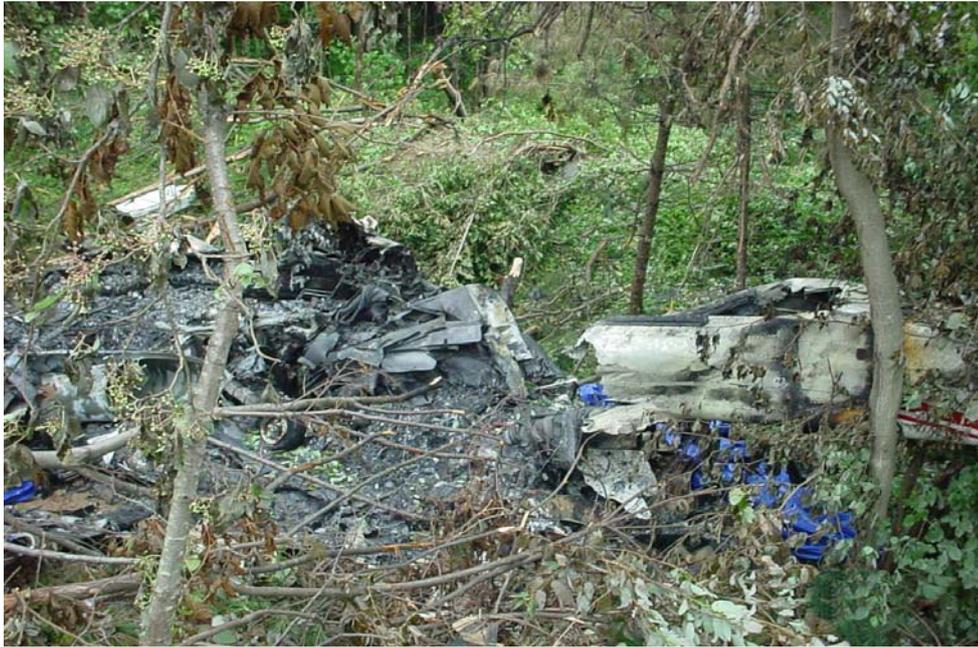
[Photo 4] Wreckage of the helicopter after fire was extinguished

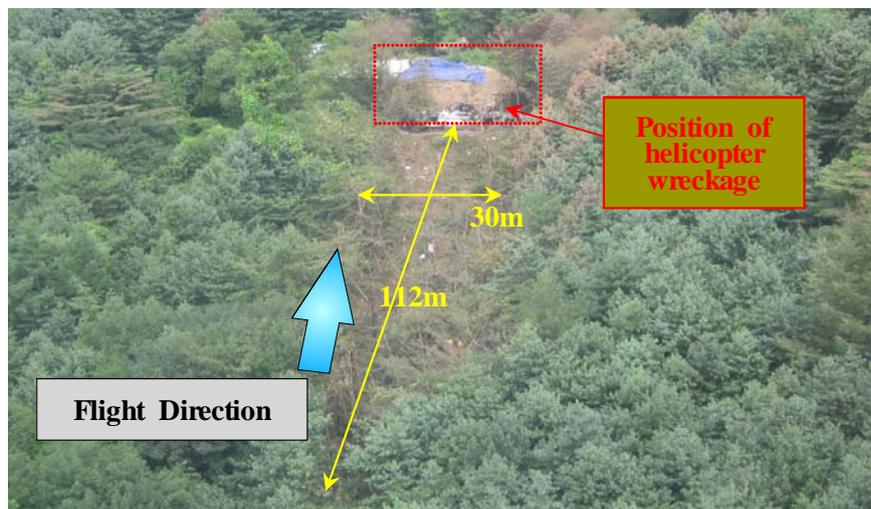
When HL9292 impacted the ground, the forest was damaged 112m long and 30m wide. After HL9292 crashed, the loaded fuel and oil leaked to contaminate soil 5m wide and 15m long.

[Photo 5] Overview of the helicopter crash site

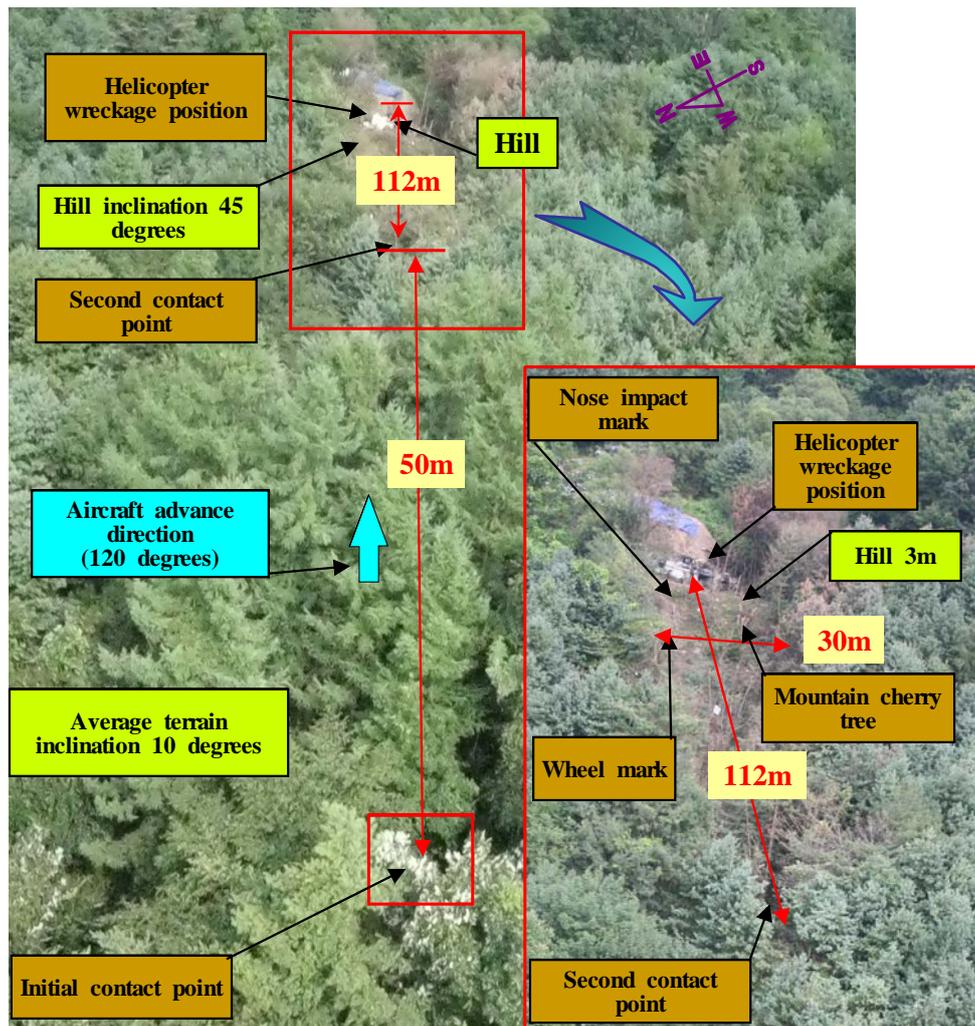
The cherry tree⁷⁴⁾ which was 7m left in the direction of 300 degrees from the crash point was broken by four of main rotor blades impact. And the one of four blades was broken and lying beside the mountain cherry tree.

[Photo 8] Overview of the crash site

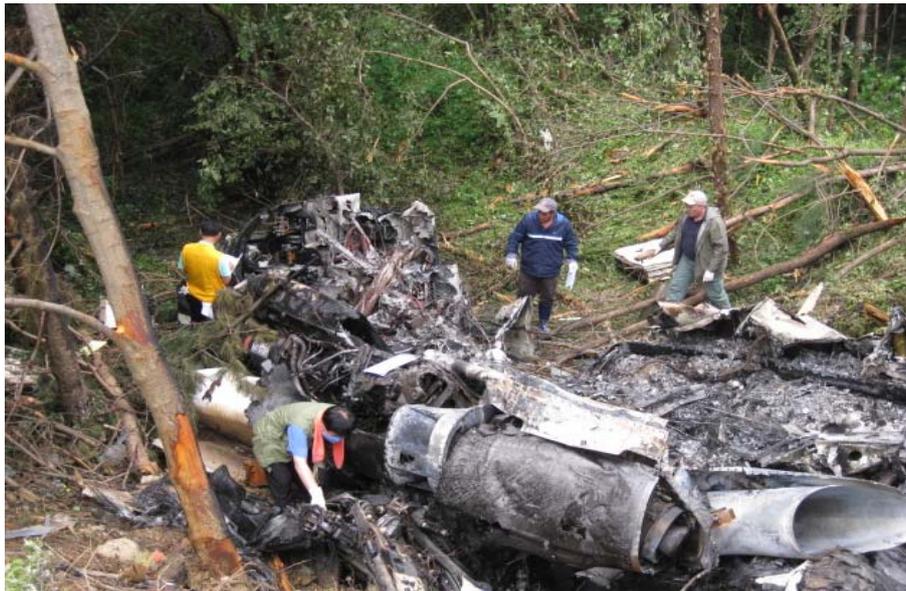
The fuselage caught a fire while it was overturned to the left. Except for the part of the left fuselage skin, the whole of it was burned down, so it was impossible to confirm the condition of each component part. [Photos 9 and 10] below show the fuselage portion that was burned down completely.

[Photo 9] The exterior of fuselage after fire

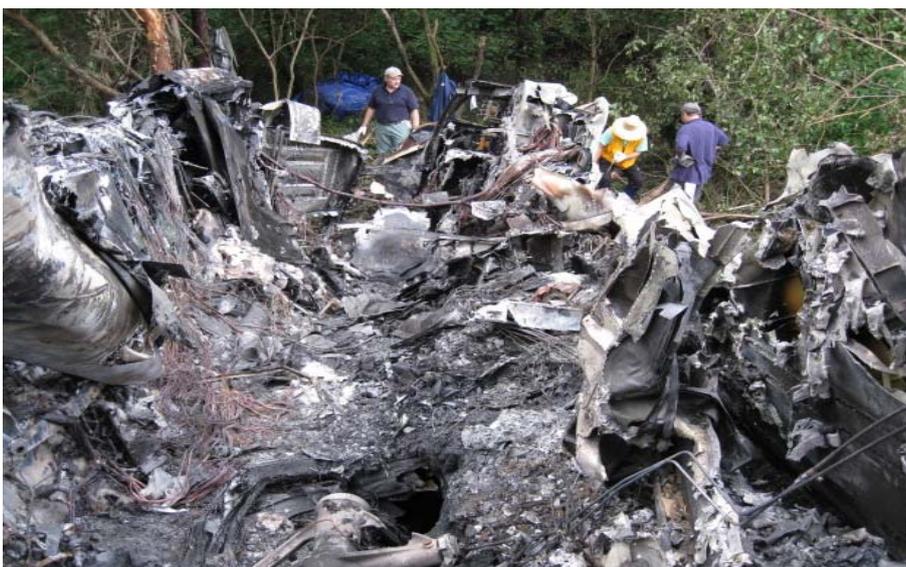
[Photo 10] The interior of fuselage after fire

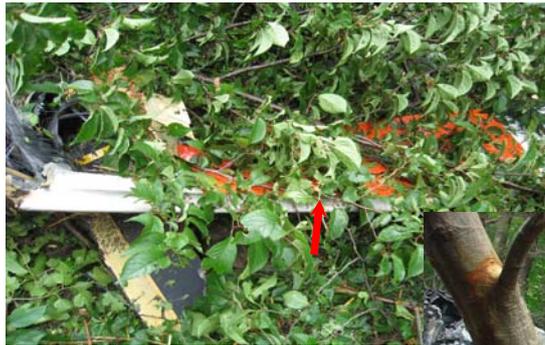
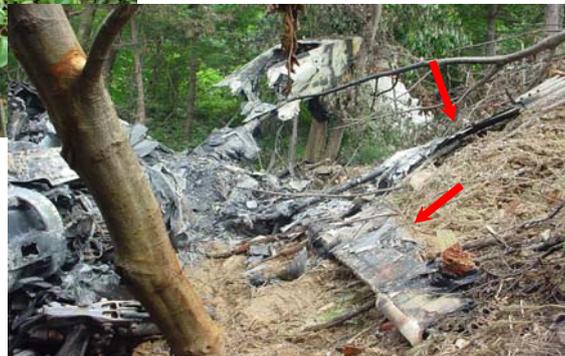
One of four main rotor blades was broken and dropped by the mountain cherry tree. The other three were dropped on the slope beside the fuselage. All the three had the tip cut, the root bent, remained stuck to the main rotor hub and damaged by fire. [Photo 11] below shows the damage to the main rotor blades.

◀ Fragments of main rotor blades
by mountain cherry tree

Wreckage of main rotor broken
and burned down ▶

[Photo 11] Damage to the main rotor

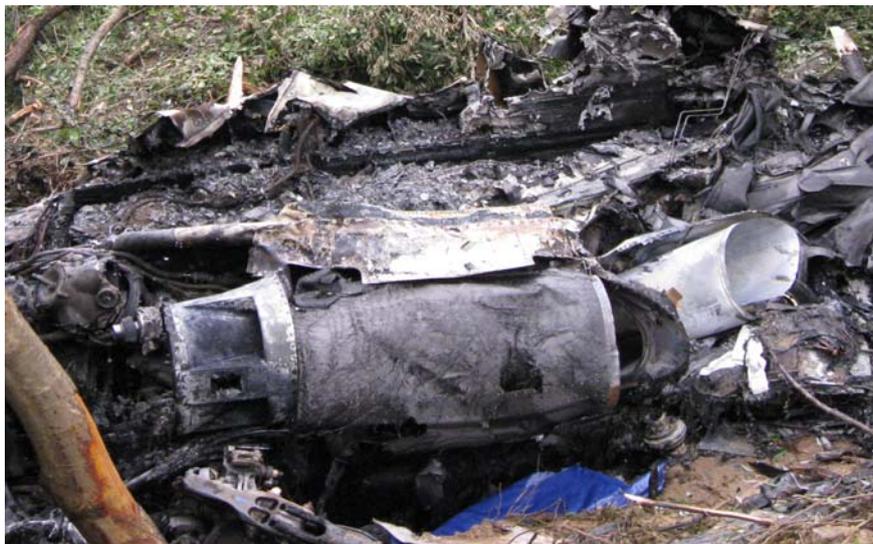
[Photo 12] Engine burnt down

The engine including the cowling was completely burned down by the fire to the extent that only its form was identifiable, and the exact firing point was not confirmed. [Photo 12] shows what happened to the engine.

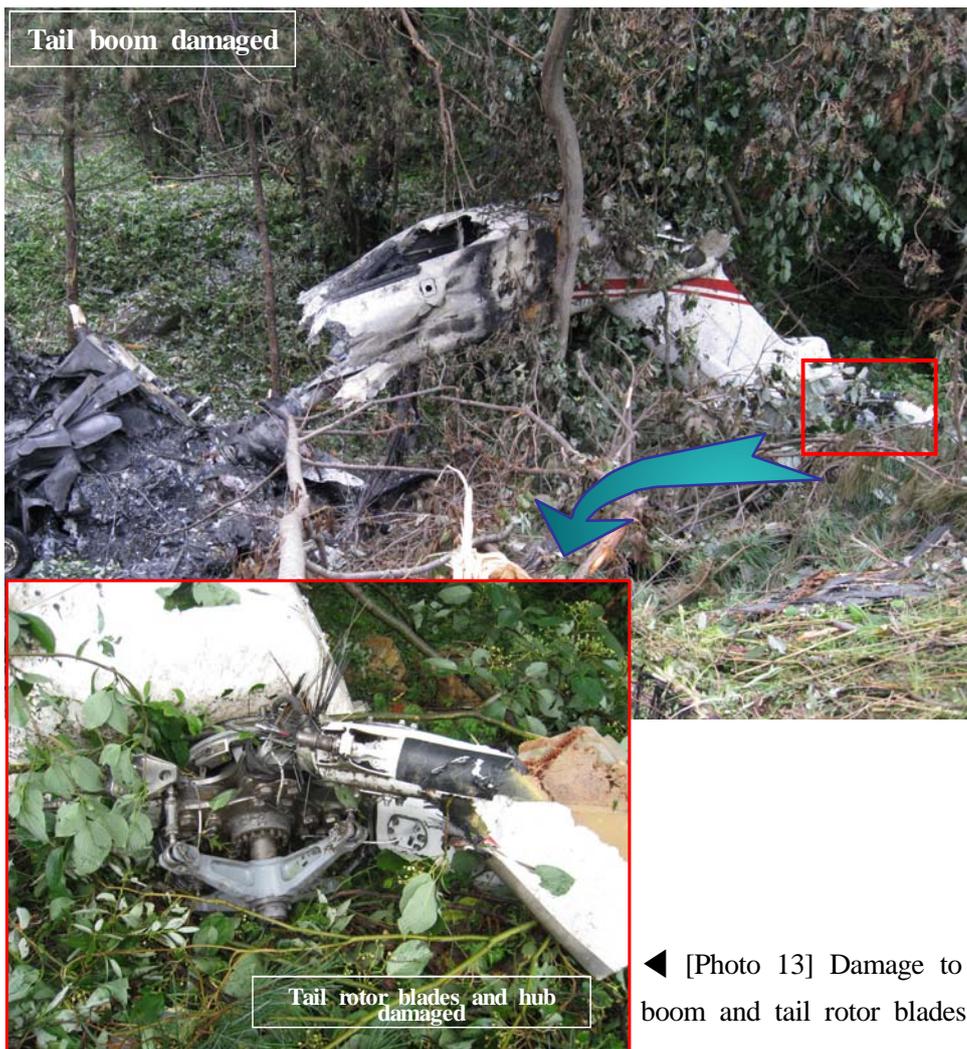
The separated tail boom was not burnt despite the fire, and the vertical stabilizer was upside down 180 degrees and dropped to the ground.

◀ [Photo 13] Damage to tail boom and tail rotor blades

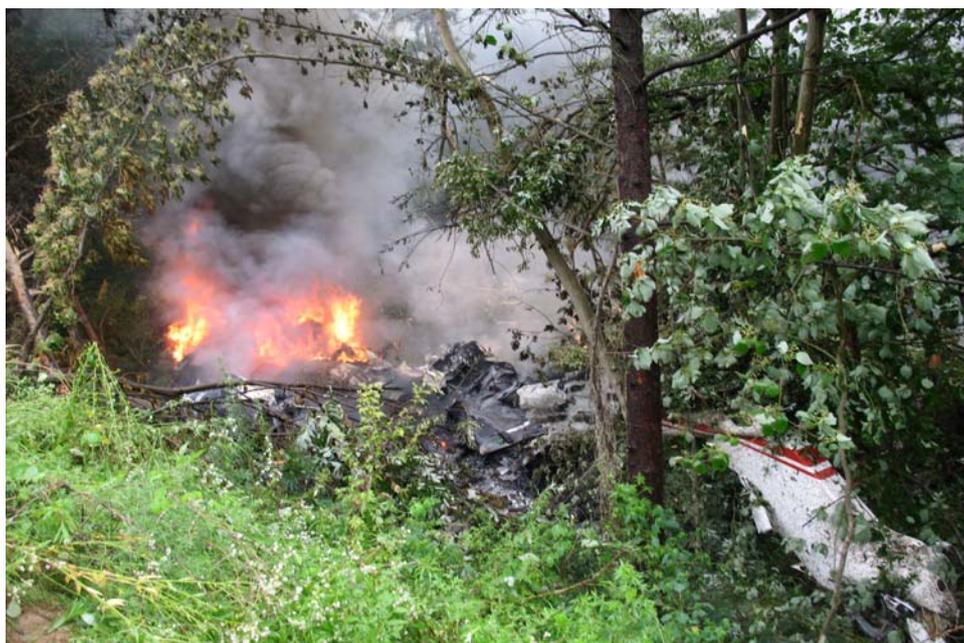
On-site investigation did not discover any evidence that a fire broke out before HL9292 crashed. The vestiges of fire were confirmed at the location where HL9292 stopped eventually and the fire did not spread to the ground area around. [Photo 14] shows a fire breaking out.

[Photo 14] Aircraft after the crash

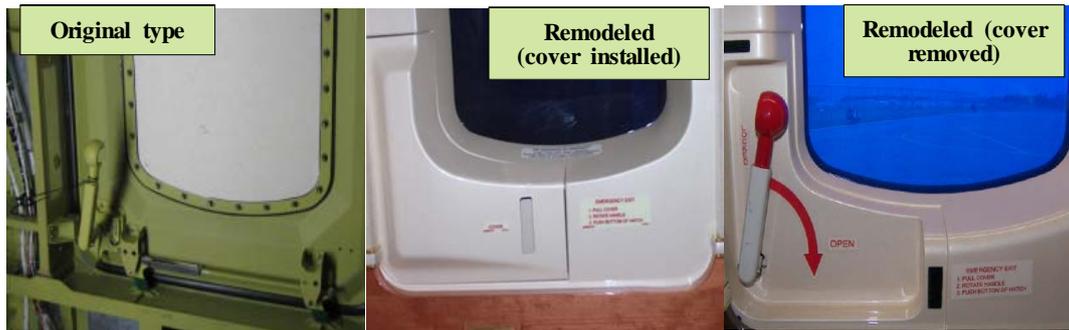
When compared the safety information card⁸⁵⁾ submitted by the Tong-il Aviation and the safety information card by Sikorsky Company, along with actual aircraft⁸⁶⁾ of Sikorsky, there were some noticeable discrepancies. The description of emergency exits with different shapes and some essential points were missing in the safety information card prepared by the Tong-il Aviation. Also, the shape and the position of the emergency exit handles were manufactured differently from the actual ones.

[Photo 15] Open-and-shut handle and cover of the remodeled emergency exit

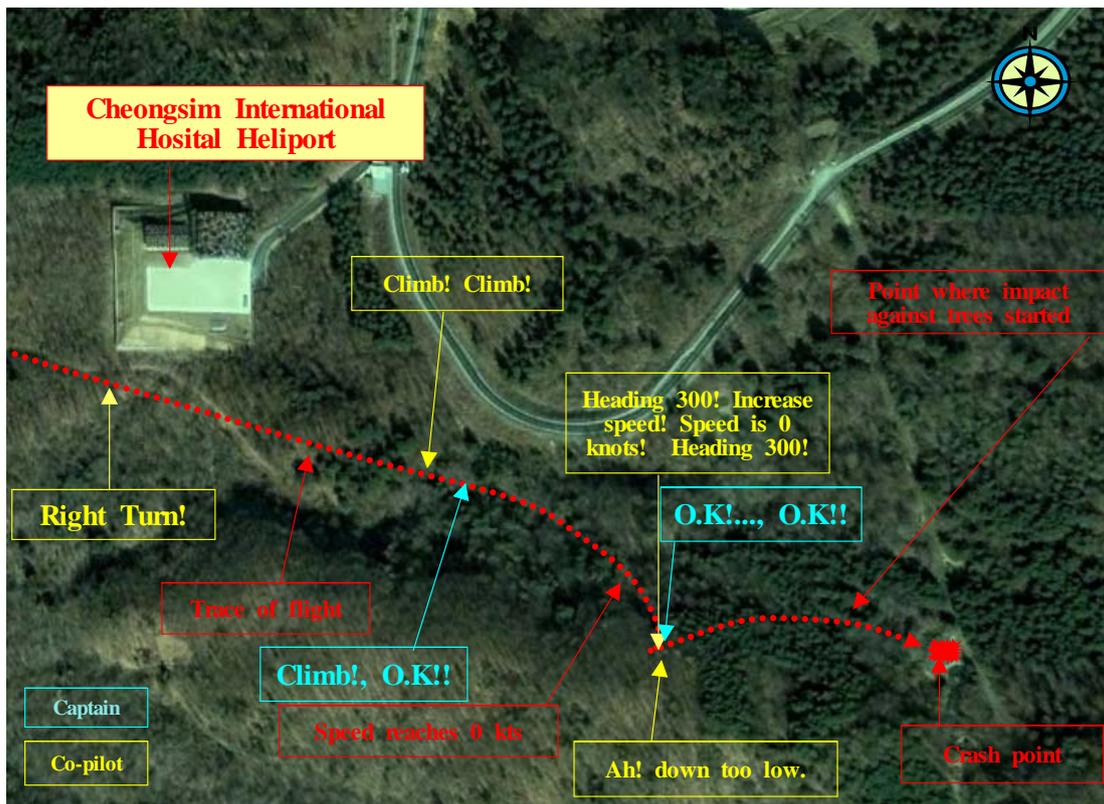
In addition, that HL9292 could not maintain the heading 300 degrees in clouds after passing the Hospital Heliport, that the speed was decreased to 0 kts, and that the pitch was excessively lowered to increase the helicopter speed, and that he failed to maintain the helicopter attitude without responding adequately to the co-pilot's advice are judged to be caused by a vertigo when he was in a panic as he failed to identify and the heliport and passed it.

[Photo 17] Trace of flight in the final phase before the crash
