**INCIDENT**

<b>Aircraft Type and Registration:</b>	Sikorsky S-92A, G-CHCK	
<b>No &amp; Type of Engines:</b>	2 General Electric CT7-8A turboshaft engines	
<b>Year of Manufacture:</b>	2006	
<b>Date &amp; Time (UTC):</b>	23 April 2007 at 0750 hrs	
<b>Location:</b>	Approximately 65 nm north-east of Aberdeen	
<b>Type of Flight:</b>	Commercial Air Transport (Passenger)	
<b>Persons on Board:</b>	Crew - 2	Passengers - 15
<b>Injuries:</b>	Crew - None	Passengers - None
<b>Nature of Damage:</b>	In-flight separation of a tail rotor pivot bearing	
<b>Commander's Licence:</b>	Airline Transport Pilot's Licence	
<b>Commander's Age:</b>	52 years	
<b>Commander's Flying Experience:</b>	16,390 hours (of which 214 were on type) Last 90 days - 113 hours Last 28 days - 37 hours	
<b>Information Source:</b>	AAIB Field Investigation

**Synopsis**

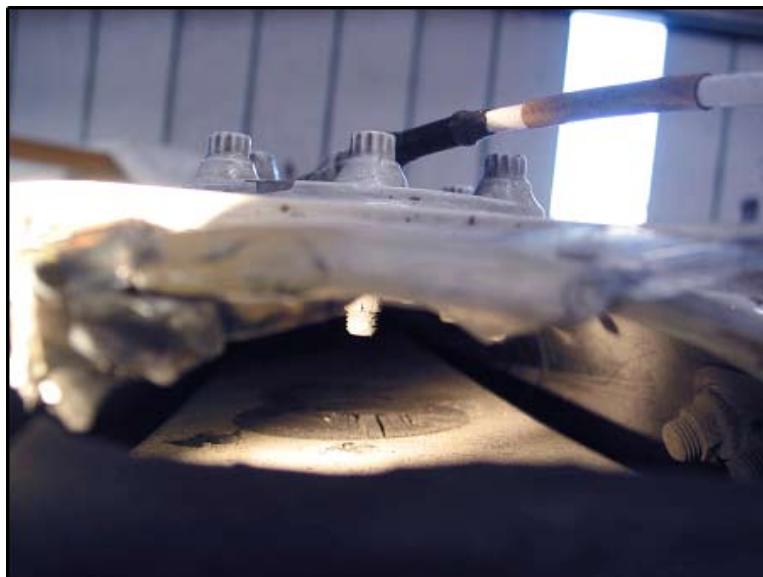
**Figure 3 (left)**

It was evident that the larger part of the outboard pivot bearing and its retainer had detached (Figure 3) and migrated outwards inside the torque tube under centrifugal loading, becoming jammed between the torque tube and the flexible spar (Figure 4). The inboard bearing retainer had also detached from the flexible spar and travelled

View inside G-CHCK tail rotor blade torque tube showing missing pivot bearing

The sudden onset of vibration during the flight suggests that a rapid in-flight separation of the outboard pivot bearing occurred, causing the greater part of the bearing to detach and migrate further up the torque tube under centrifugal force. The resultant change in the centre of mass of the blade would have caused the tail rotor to become out of balance, producing the reported high vibration levels.

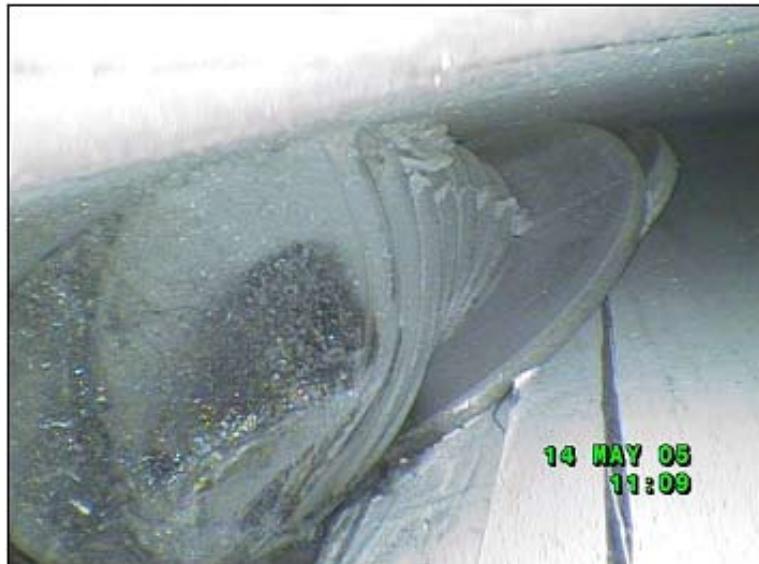
**Figure 4 (right)**

View inside torque tube of G-CHCK tail rotor blade showing detached outboard pivot bearing trapped between torque tube and flexible spar

All of the above suggests that the bearing separation on G-CHCK was probably preceded by the disbond of either one or both of the bearing retainers from the flexible spar. This would have caused the inner end of the pivot bearing to become unrestrained, allowing it to deflect outwards in a spanwise direction under centrifugal loading when the tail rotor was rotating. This would place the elastomer under considerable strain. In this case, the elastomer eventually separated, allowing the greater part of the outboard pivot bearing to detach and to be centrifuged up inside the blade torque tube.

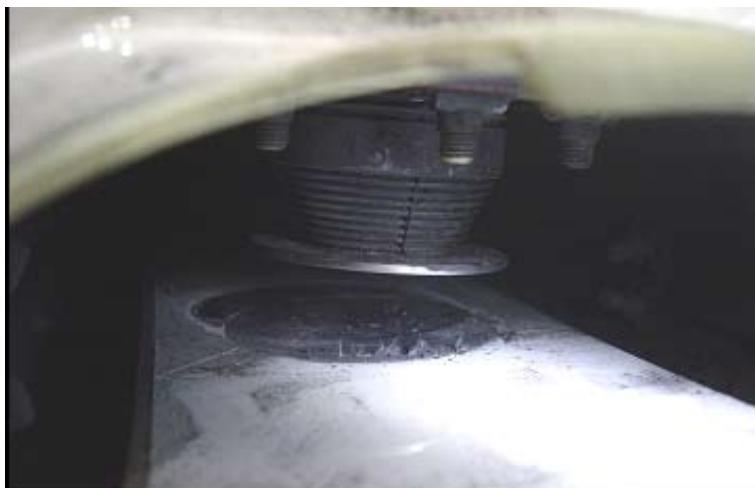
**Figure 5 (left)**

up inside the torque tube, but the inboard bearing was undamaged (Figure 5). Overlapping circular witness marks were visible on both sides of the flexible spar (Figures 5 and 6), corresponding to the original position of each bearing retainer and the newly adopted positions after the retainers had disbanded from the flexible spar. Similar witness marks were found on the flexible spar of another of the operator's S-92 helicopter, serial number 920013, which had also suffered a disbond of a bearing retainer. This blade was also removed and sent to the helicopter manufacturer for examination.

G-CHCK tail rotor inboard pivot bearing showing missing bearing retainer and overlapping circular witness marks

The overlapping circular witness marks on both sides of the flexible spar represented the initial position where the retainer was bonded to the spar and the new relaxed position of the bearing after the retainer had disbanded. Inspections of other S-92 helicopters since this incident have identified other retainers that had disbanded, producing similar witness marks on the flexible spar.

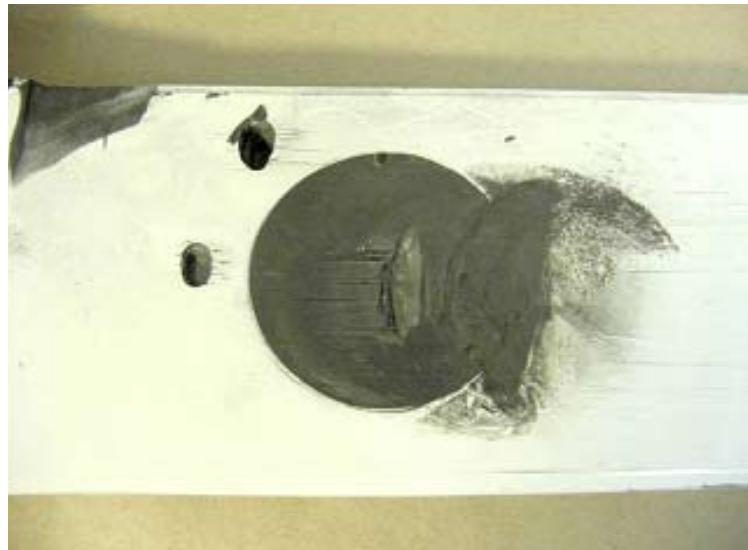
**Figure 6 (right)**

G-CHCK flexible beam outboard side showing witness marks produced by bearing retainer
