Report No. ARAIB/AAR0801

AIRCRAFT ACCIDENT REPORT

**CRASHED INTO TERRAIN DURING LANDING
THE KOREA FAMILY FEDERATION MISSIONARY FOR
WORLD PEACE AND UNIFICATION
S92A2, HL9292
GAPYEONG-GUN, GYEONGGI-DO, REPUBLIC OF KOREA
19 JULY 2008**

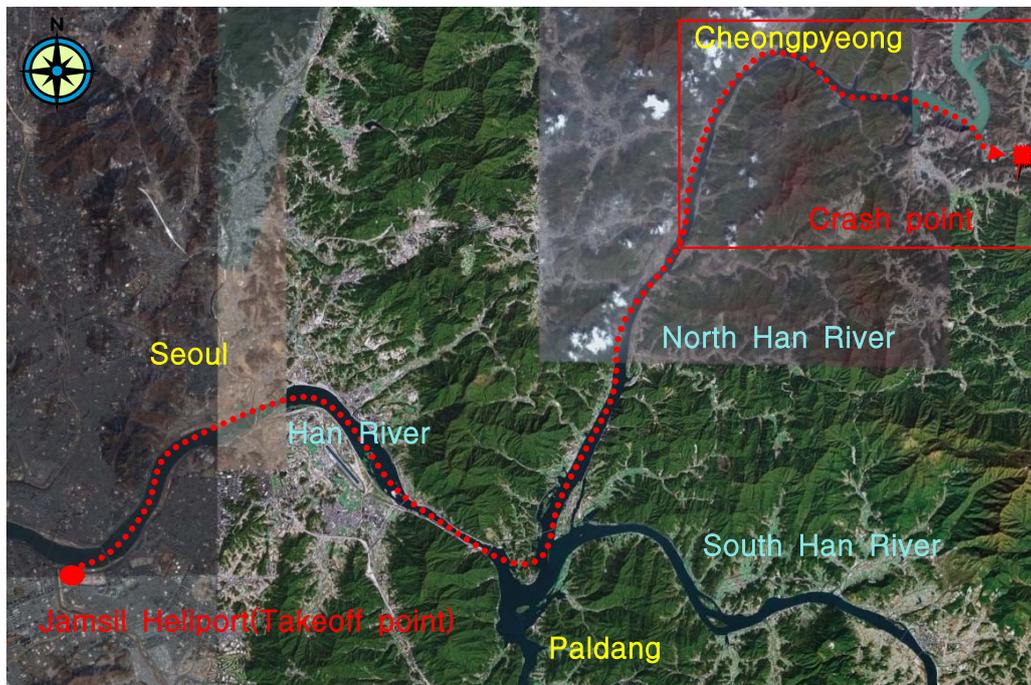
[Photo 1] Overview from Jamsil Heliport to crash site

[Photo 1] is the flight path from Jamsil Heliport to the crash point, and [Photos 2 and 3] are the details of the flight path.

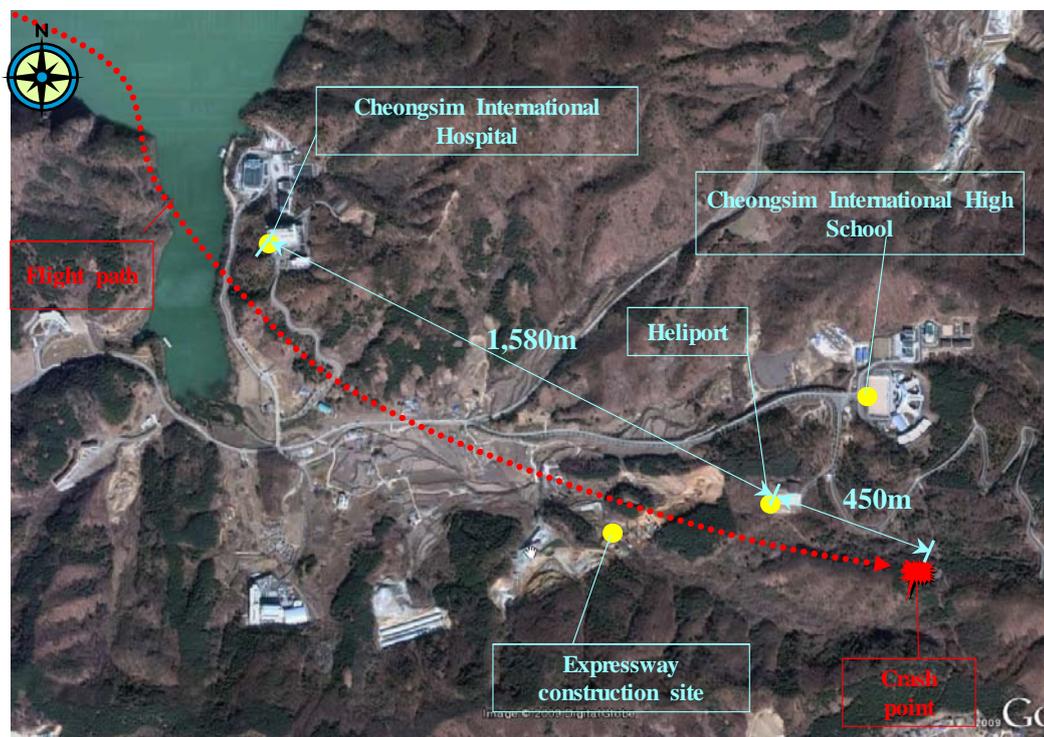
[Photo 3] Flight path from Cheongsim International Hospital to crash site

HL9292 flew at a speed of 62 kts for about 1 minute and 30 seconds, from 17:04:15 to 17:05:44.5, the moment the autopilot mode was released. Then for about 21 seconds, from 17:05:51 to 17:06:12, the aircraft made a 360 degree right turn climbing almost in the same place at a speed of 0 kts.

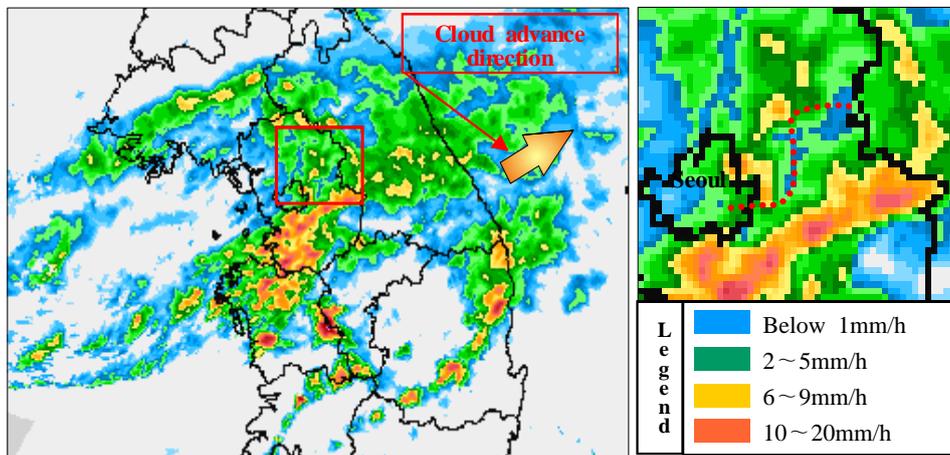
[Fig. 2] Rain cloud distribution shown on radar screen 16:40

According to [Fig. 2], a strong cloud zone of about 20 mm per hour was formed south of the flight path (red dotted line) at 16:40, and heavy rain cloud zones of about 6~9mm per hour were formed also west of the flight path and northwest of the landing planned point. However, regardless of harsh weather condition, there was rainfall less than about 1 mm per hour only at the crash point.

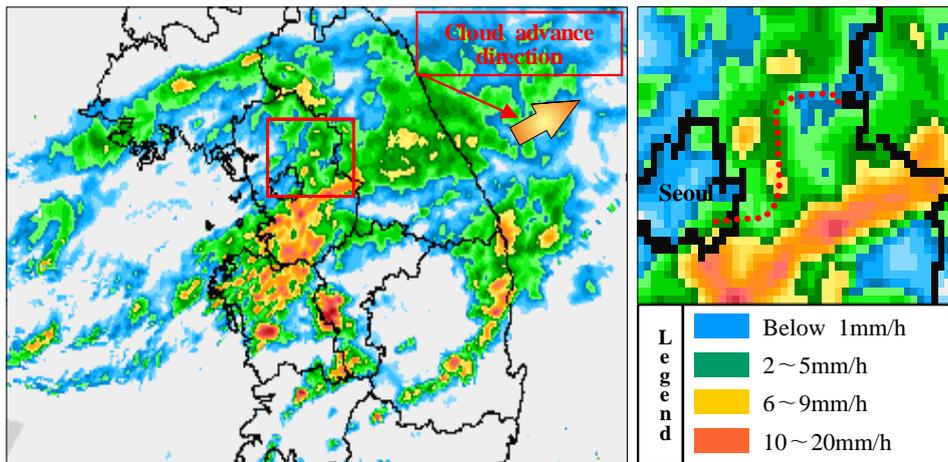
[Fig. 3] Rain cloud distribution shown on radar screen 16:50

As shown in [Fig. 3], clouds were moving toward east on the whole, and especially the weak rain cloud of the landing point was going out east.

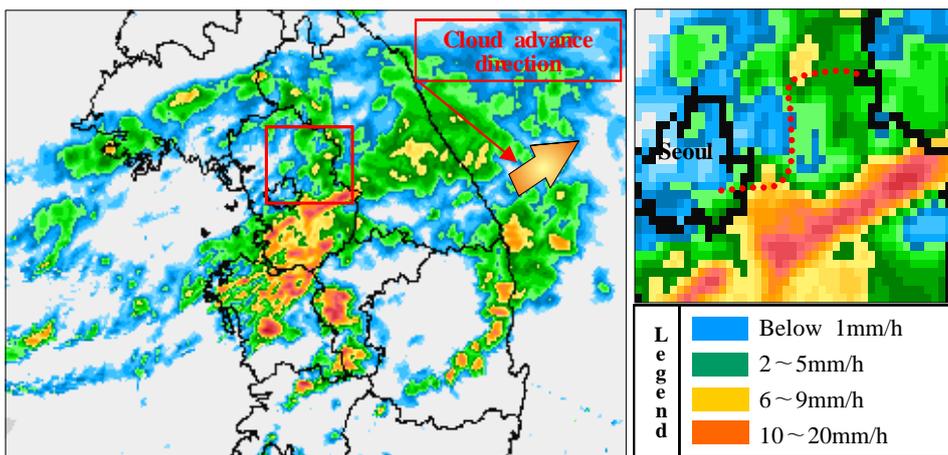
[Fig. 4] Rain cloud distribution shown radar screen 17:00

In [Fig. 4] at 17:00, a strong rain cloud zone of about 10~20 mm per hour was positioned lengthily east to west in the south of the flight path, and on the flight path a weak rain cloud of less than 1 mm per hour was approaching from the west.

But near the landing point, the weak rain cloud zone of less than 1 mm per hour that was distributed until 10 minutes earlier is going out to east while a rain cloud zone of about 2~5 mm per hour is pushing and covering from the west.

Upon checking the weather observation radar images (See Figs. 4 and 5) at the time of the crash, it was concluded that a rain cloud zone of about 2~5 mm per hour was covering over the crash point.

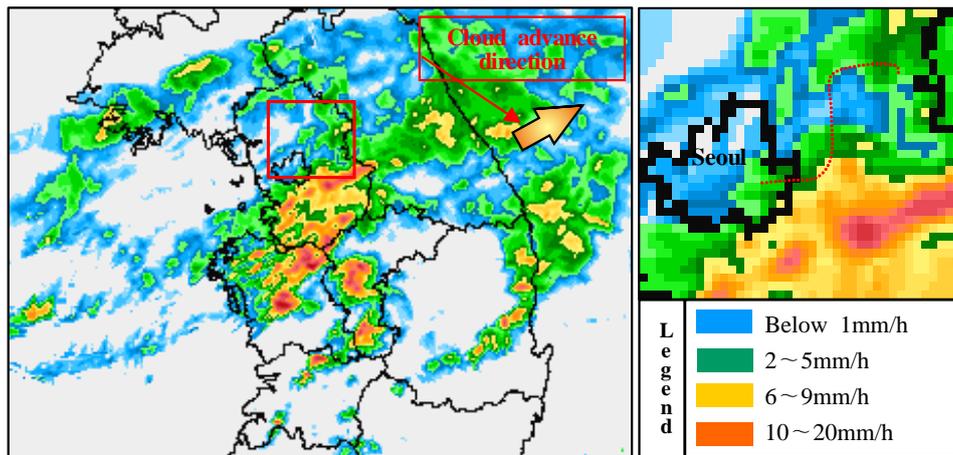
[Fig. 5] Rain cloud distribution shown on radar screen 17:10

As shown in [Fig. 5], at 17:10 the clouds near the landing point are moving northeast and the rain clouds are becoming weaker.

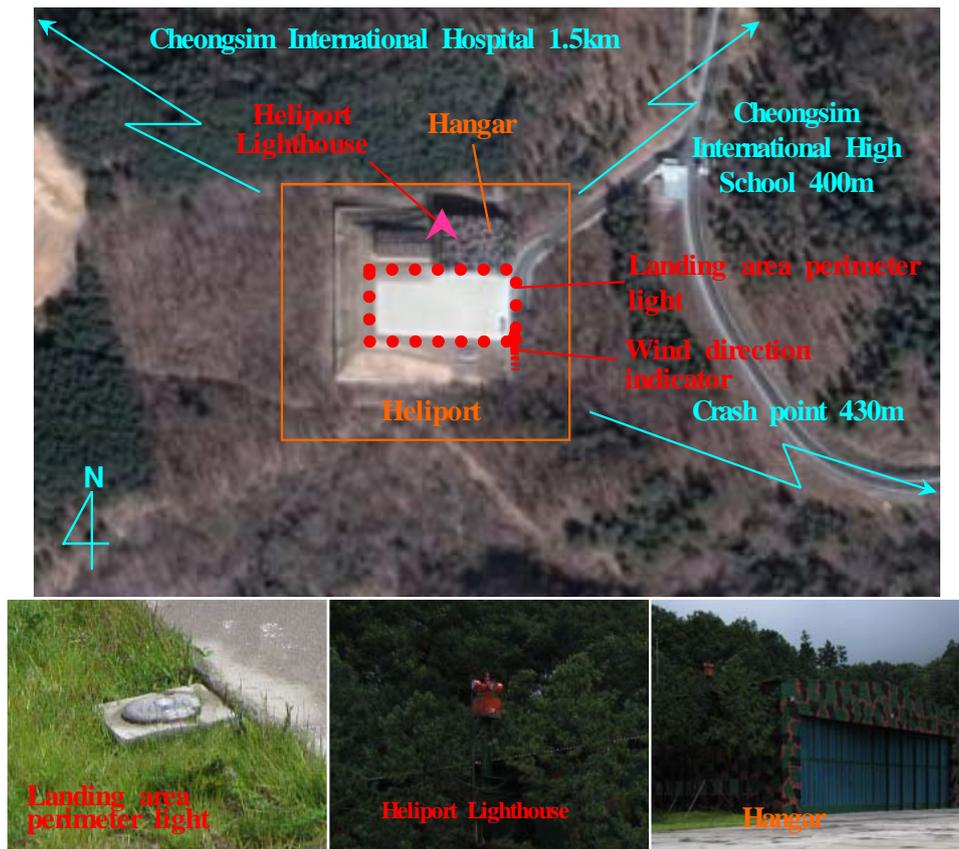
[Photo 7] Cheongsim Hospital Heliport facilities

The surface of the heliport is paved with concrete, its elevation 167 m (550 ft), and the size of pavement is 60m wide and 30m long. The heliport has several installations, such as a heliport lighthouse, wind direction light, landing area perimeter light, etc. There are 24 landing area perimeter lights⁵³⁾ installed along the surface area boundary of the landing area, and one wind direction light⁵⁴⁾ is installed at the southeast corner of the landing area which is the location of the wind direction indicator⁵⁵⁾, and the heliport lighthouse is installed on the rooftop of the hangar.

The highest peak of the Janglak Mountain, located southeast of the heliport, is formed lengthily south to north in a ridge form, and the heliport is located on the west side of the Janglak Mountain ridge. Since the terrain around the heliport slopes upward from west to east, it is relatively easy to identify the heliport if the aircraft approaches from the west side.

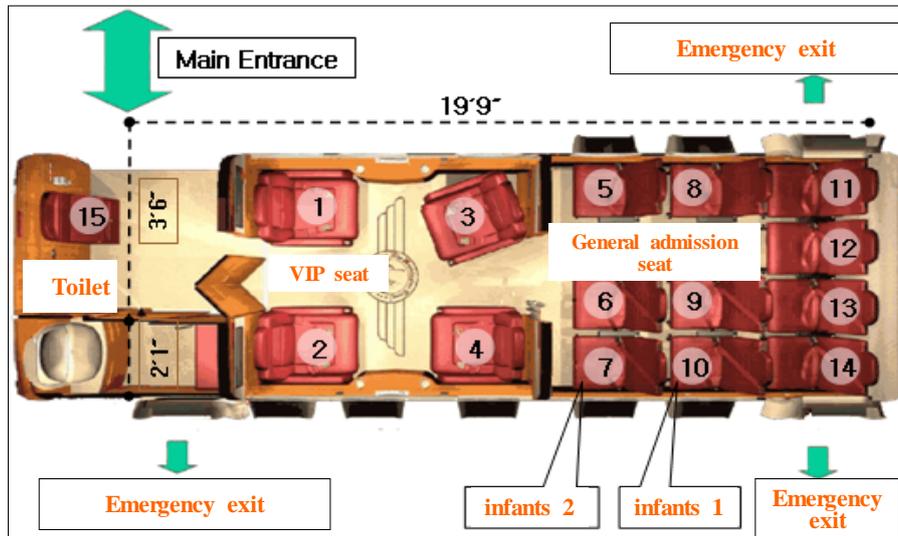
[Fig. 6] Cabin seat layout and location of emergency exits

As is shown in [Fig. 6], the cabin has 15 seats, the front cabin has a main entrance and a seat for an on-board maintenance personnel (⑮), a lavatory and an emergency exit, the middle cabin is a VIP room with four seats (①,②,③,④), the aft cabin is a general cabin with 10 seats, (⑤~⑭) and an emergency exit each on the left and right in the back.

HL9292 has three emergency exits in addition to the cockpit entrance and the main entrance however, none of the emergency exits were used⁷⁷⁾ during the evacuation of the passengers.

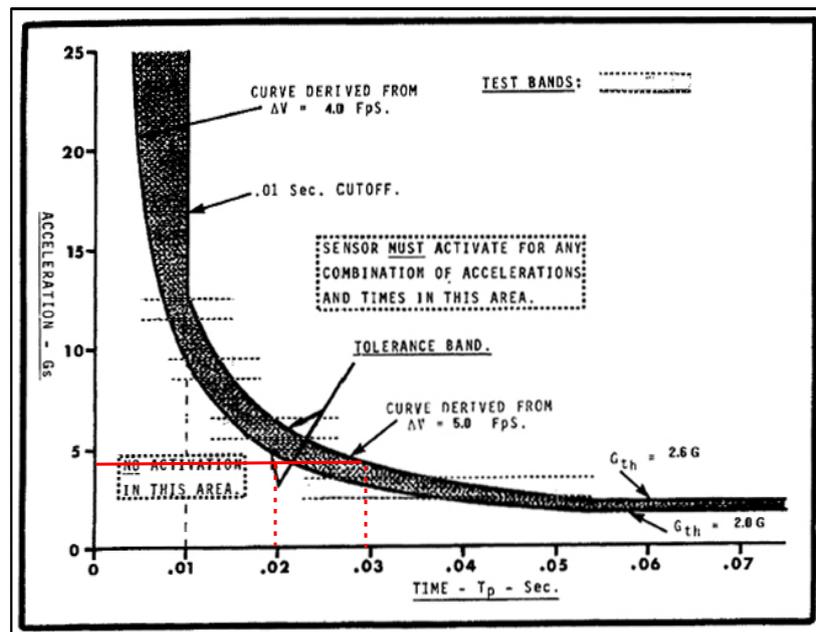
[Fig. 7] HL9292 ELT activation condition graph

The ELT installed on HL9292 transmits aircraft information⁸⁹⁾ to the satellite for 24 hours on outgoing frequencies⁹⁰⁾ when conditions⁹¹⁾ illustrated on the graph of [Fig. 7] below are created.

But considering that the speed of HL9292 was more than 80 kts at the time of the crash, it is difficult to say that the operation condition of ELT presented in [Fig. 7] was not satisfied. Therefore, the ARAIB assumed that the ELT antenna was damaged by the impact when HL9292 crashed and because of this, transmission of signals became impossible.

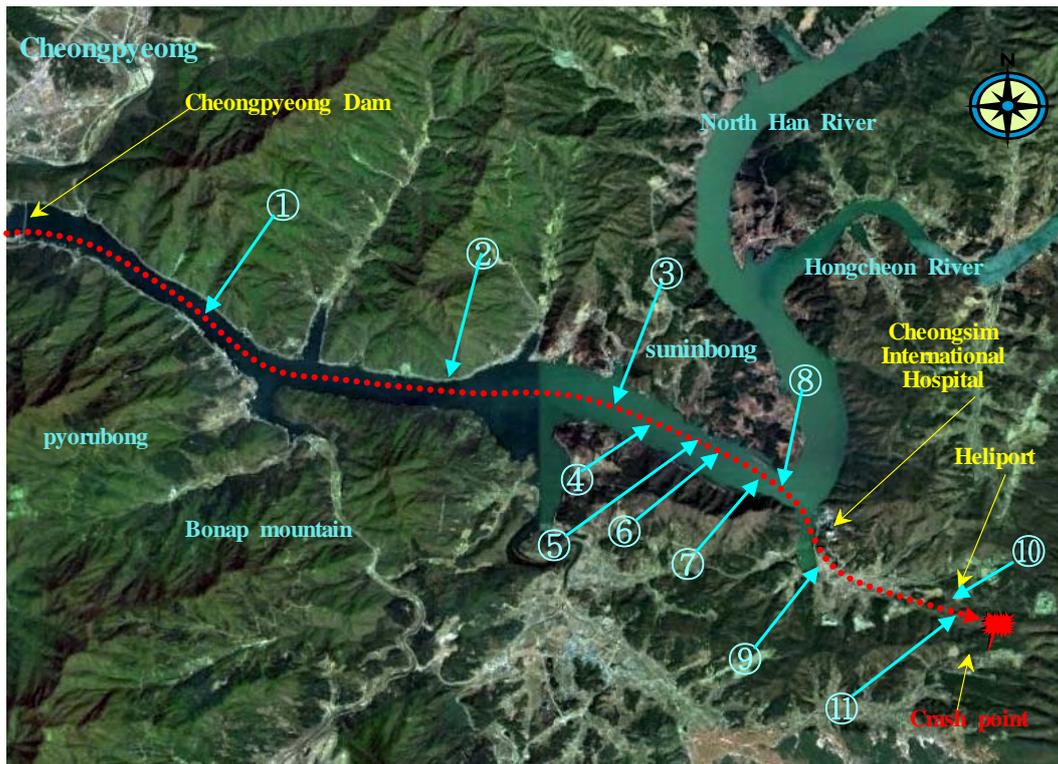
[Photo 16] Conversation between pilots on the final course and major actions taken

According to the recording of the cockpit voice recorder, the pilots could see part of the Seonin Peak about 6 km ahead of the helicopter at point ① of [Photo 16] after passing the Cheongpyeong Dam and the Cheongsim International Hospital building at point ④.

While the aircraft was approaching the Hospital Heliport, the flight altitude was at or above 1,000 ft from point ① to point ⑤, and considering the elevation of the heliport was 550 ft, the pilots could have confirmed the heliport if the visibility had been good since there were no terrain higher than the flight altitude after passing the Bbyorubong (2,210 ft) and the Bonap Mountain.

But the captain asked the co-pilot eight times while he was flying from point ⑦ to point ⑩ whether co-pilot could have (the heliport) in sight, and the co-pilot replied intermittently he had not in sight. So there was no evidence that the pilots had confirmed the heliport even if momentarily.
